**Implementation and experience of a new method for posterior vertical
bite reconstruction using direct resin composite restorations
in the private practice – a survey**

TOBIAS T. TAUBÖCK, THOMAS ATTIN & PATRICK R. SCHMIDLIN

Department of Preventive Dentistry, Periodontology and Cariology,
Center for Dental Medicine, University of Zurich, Zurich, Switzerland

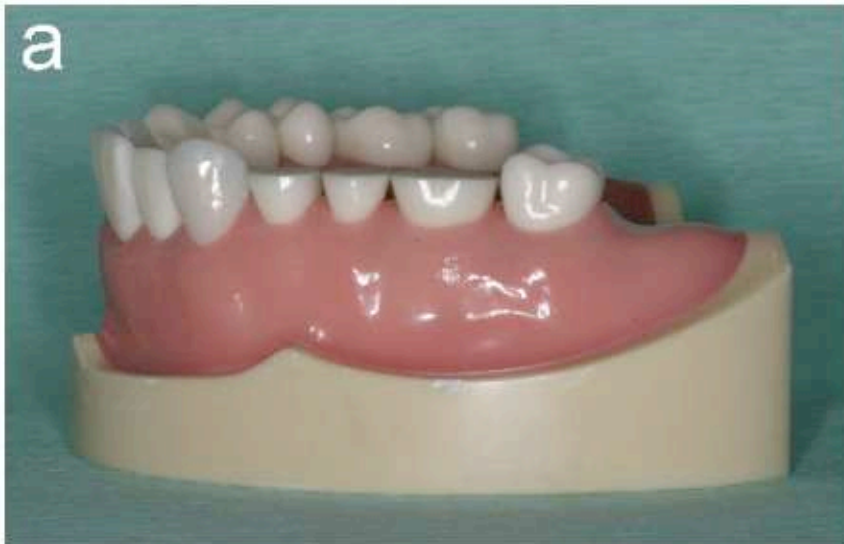
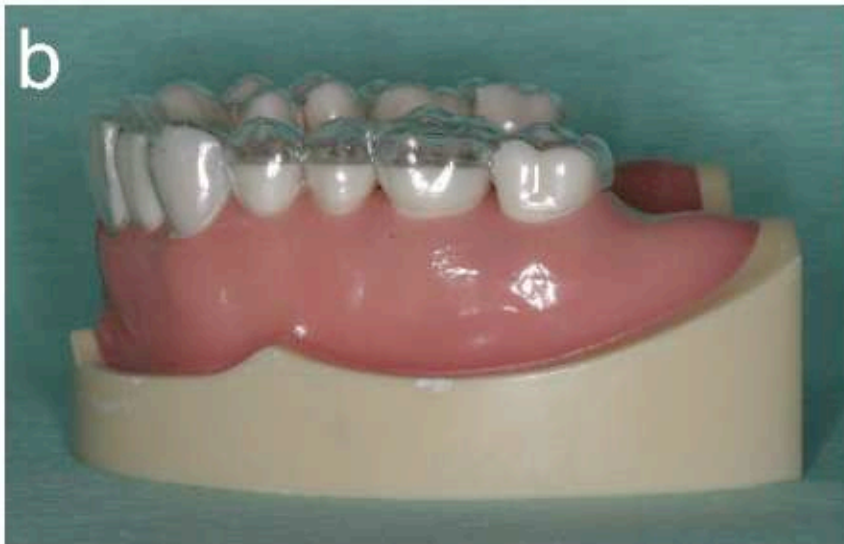
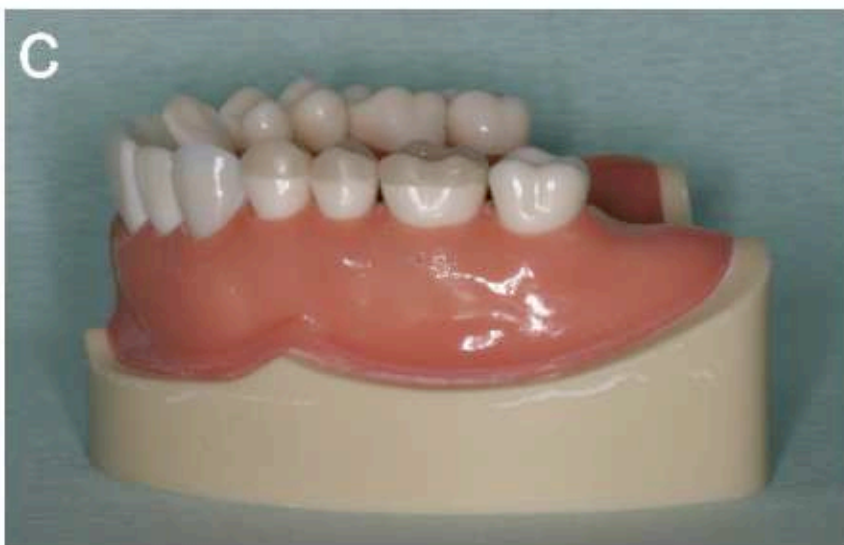
Figure 1. Typodont model with ground teeth 14 to 16 (a), positioned matrix template (b) and final resin composite restorations (c).

In the hands-on sessions of the courses the participants practiced the above-described technique for vertical bite reconstruction on typodont models mounted in dental phantom heads. They were instructed to re-build up the occlusal aspects of three teeth in one quadrant, which had been reduced in height before. The template had been produced by a technician prior to the course based on the typodont model with unprepared teeth. Figure 1 shows both a prepared typodont model and template as well as the final resin composite restorations placed by one of the course participants.
